# 000 Somewhere Street

## Roof Observation Report

**Observation Date:** 00/00/00

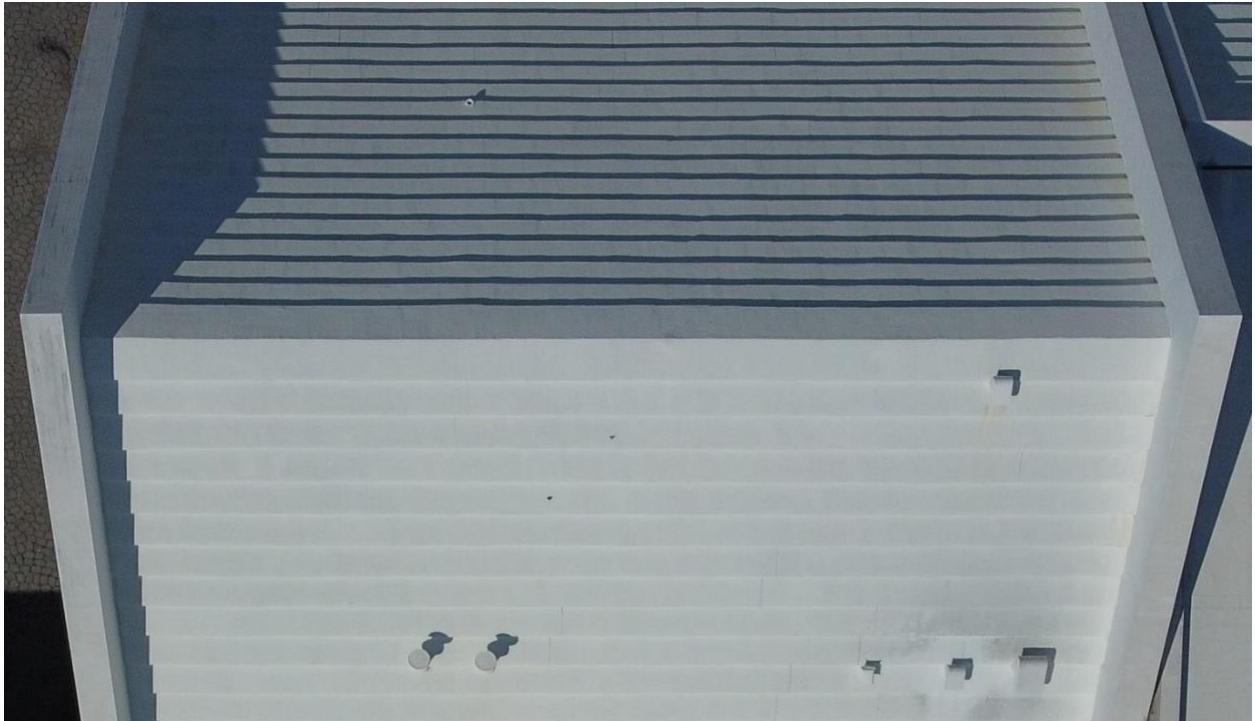
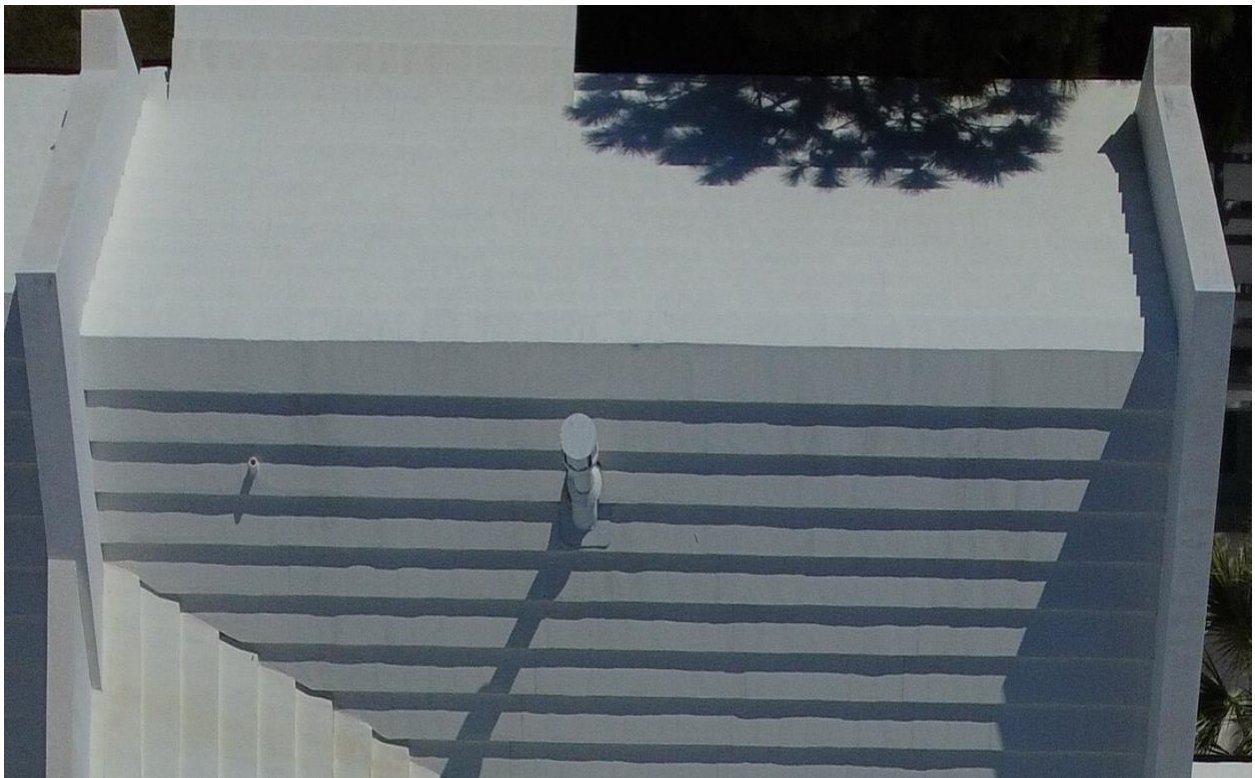
**Ridges** - Visual elevations of the ridge lines identified the ridges to be in good overall condition needing no immediate attention.

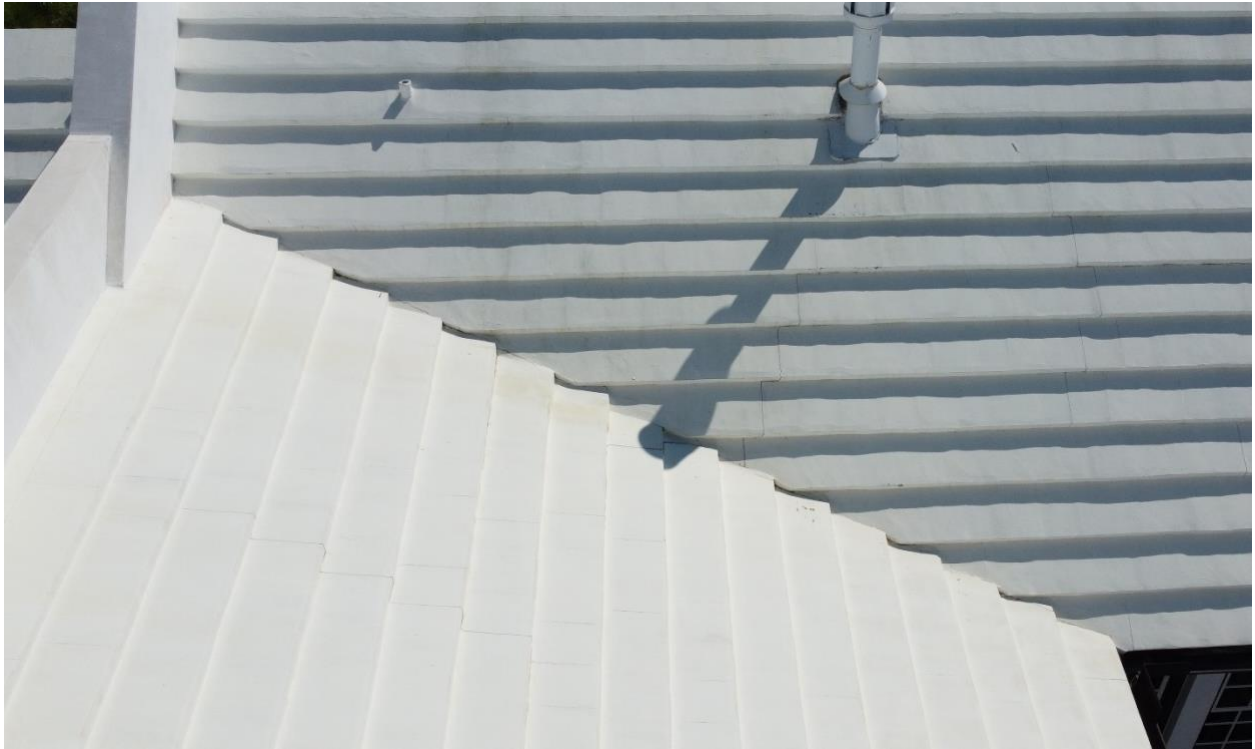
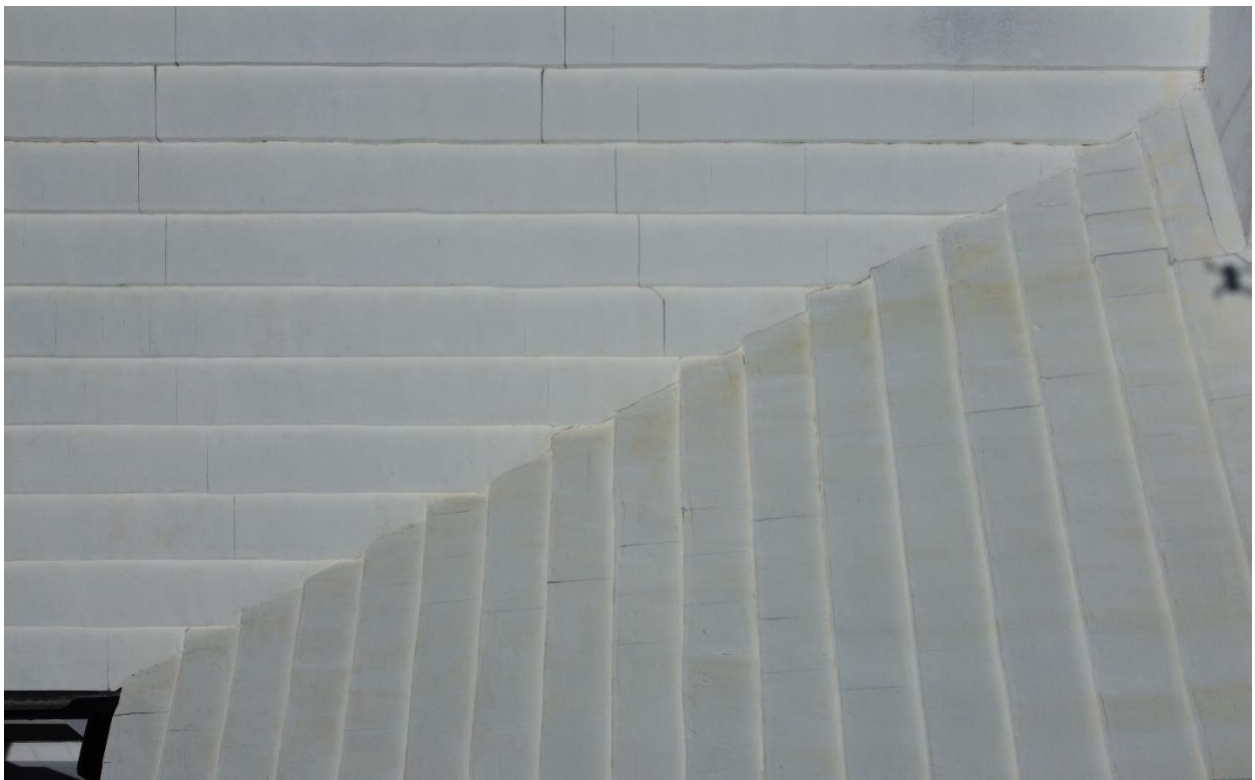
**Valleys** - Visual elevations of the valley lines identified the valleys to be in overall good condition needing no immediate attention.

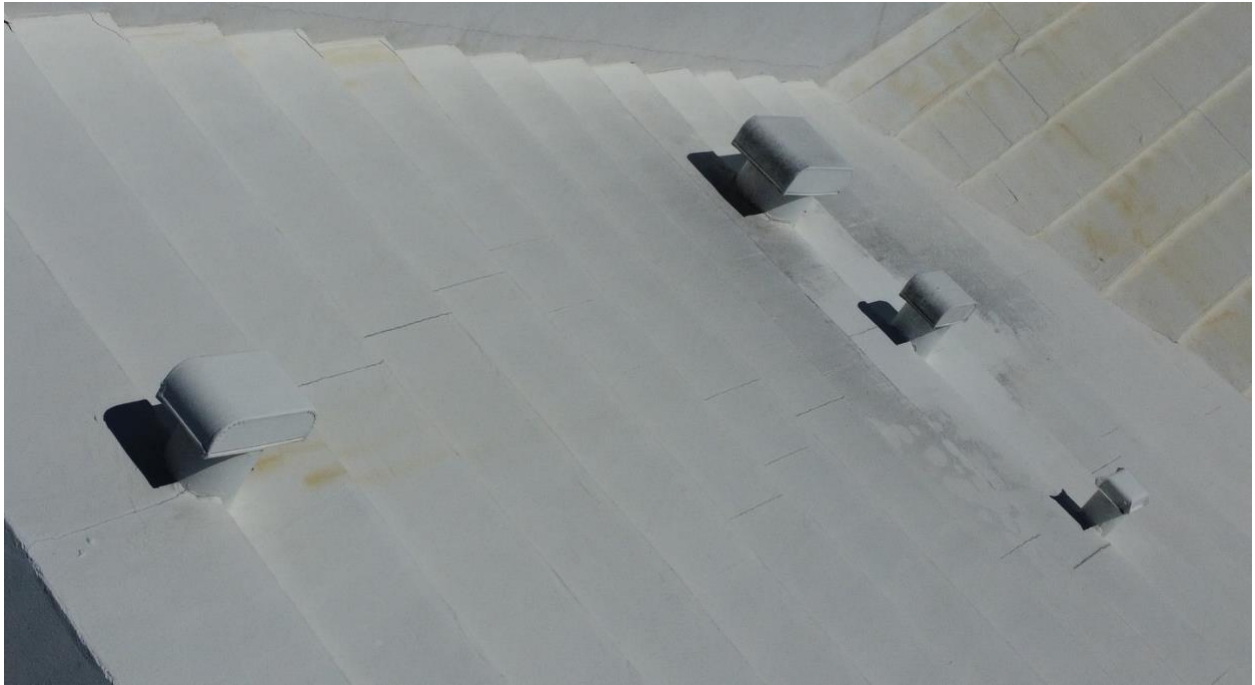
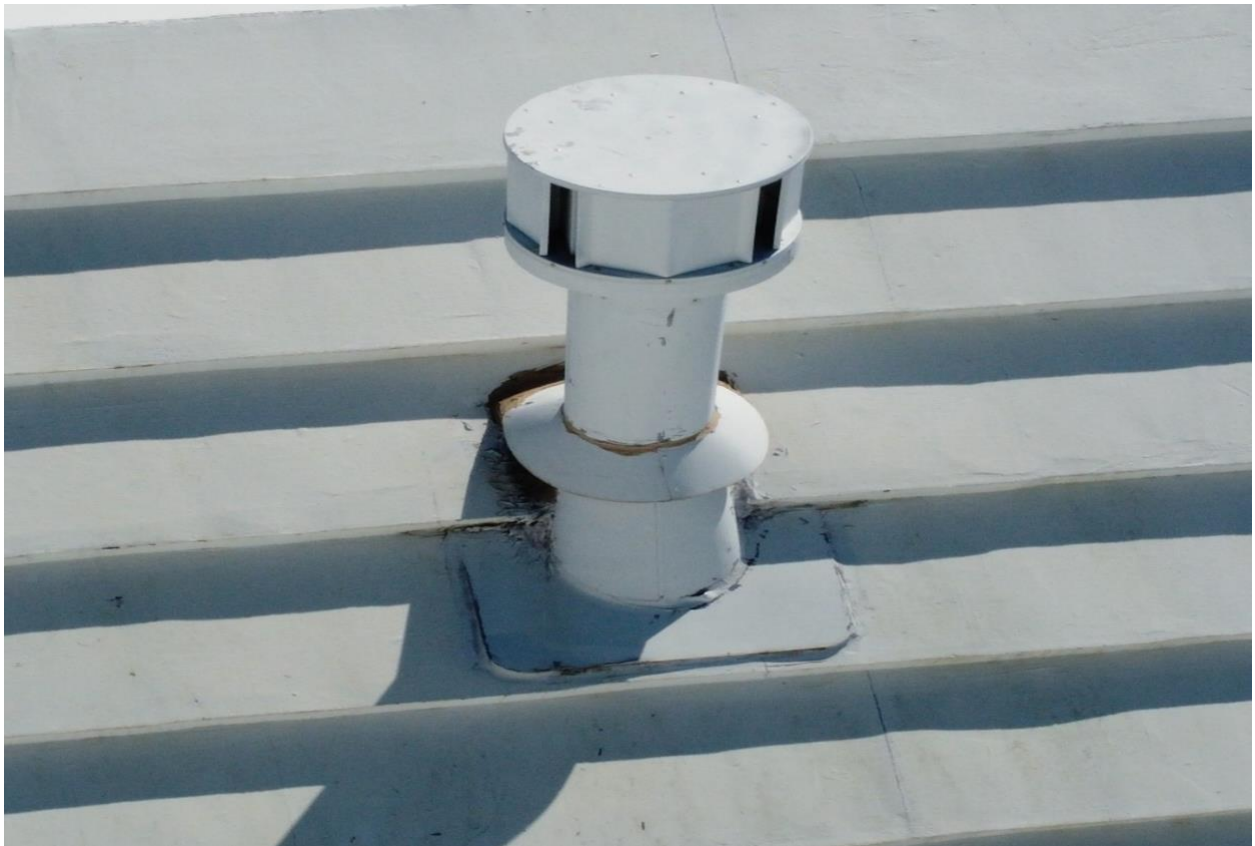
**Vents & Protrusions** - Visual elevations of roof vents and protrusions identified to be in good overall condition needing no immediate attention.

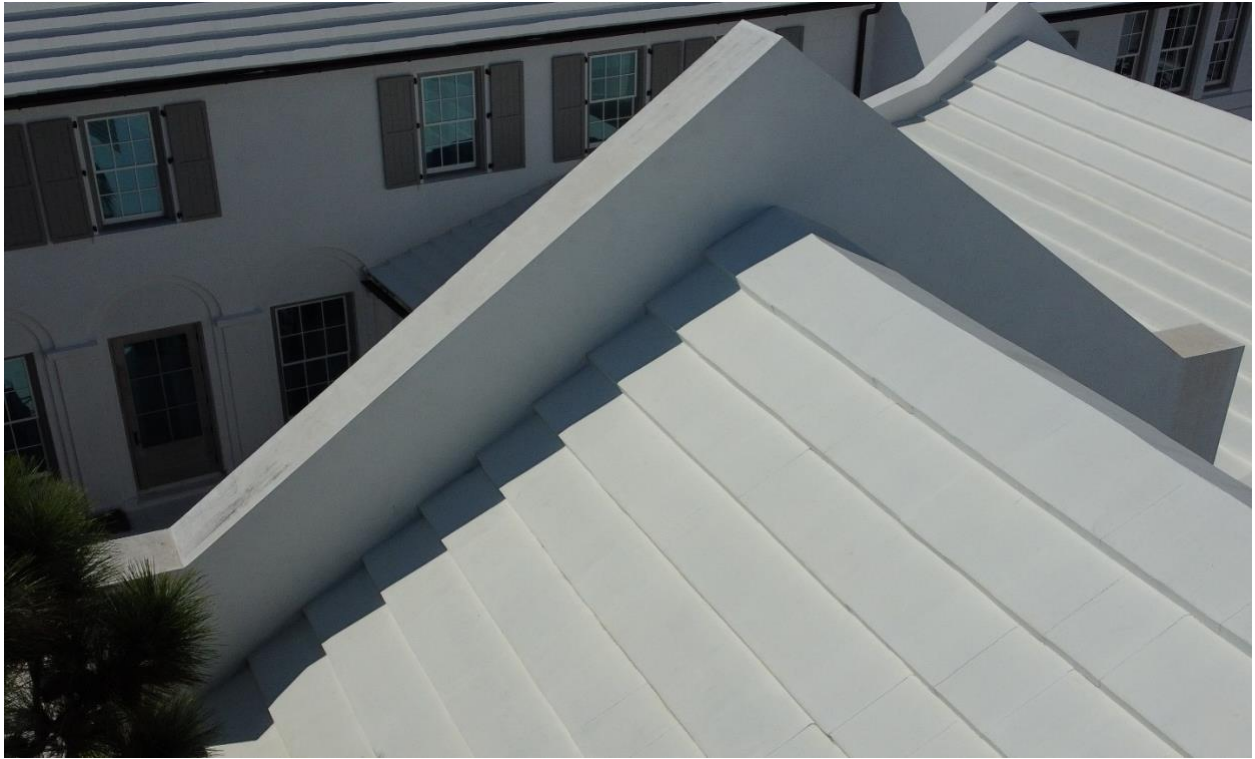
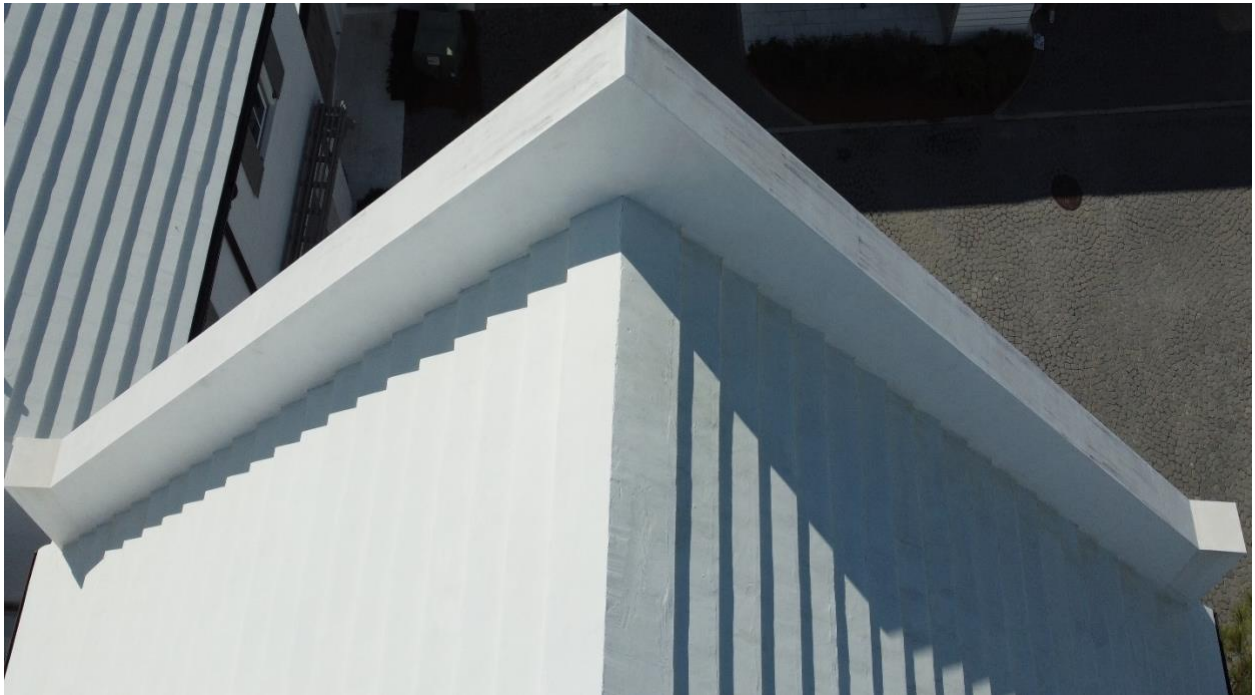
**Parapet Walls** - Visual elevations of parapet walls where roof ends identified to be in good overall condition needing no immediate attention.

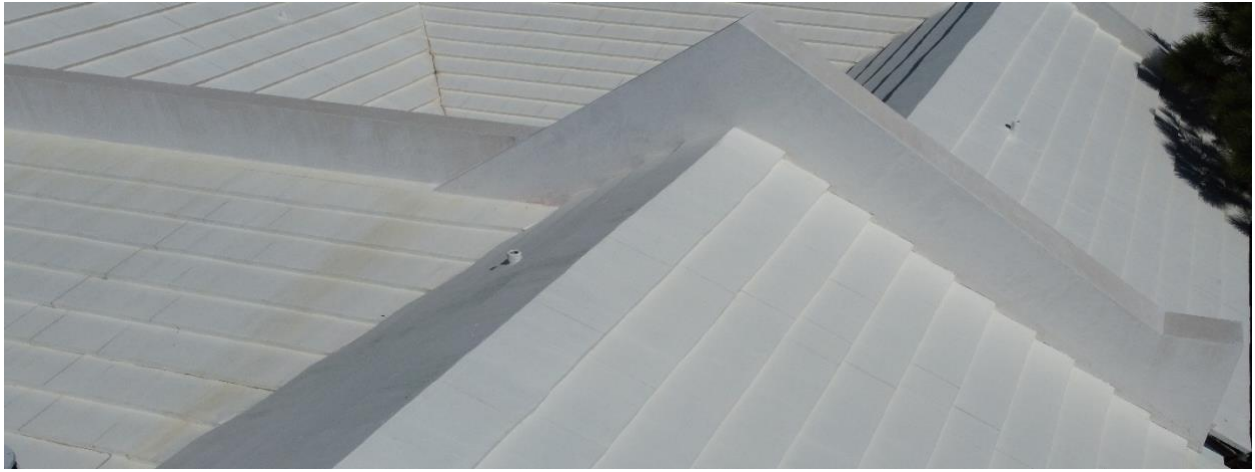
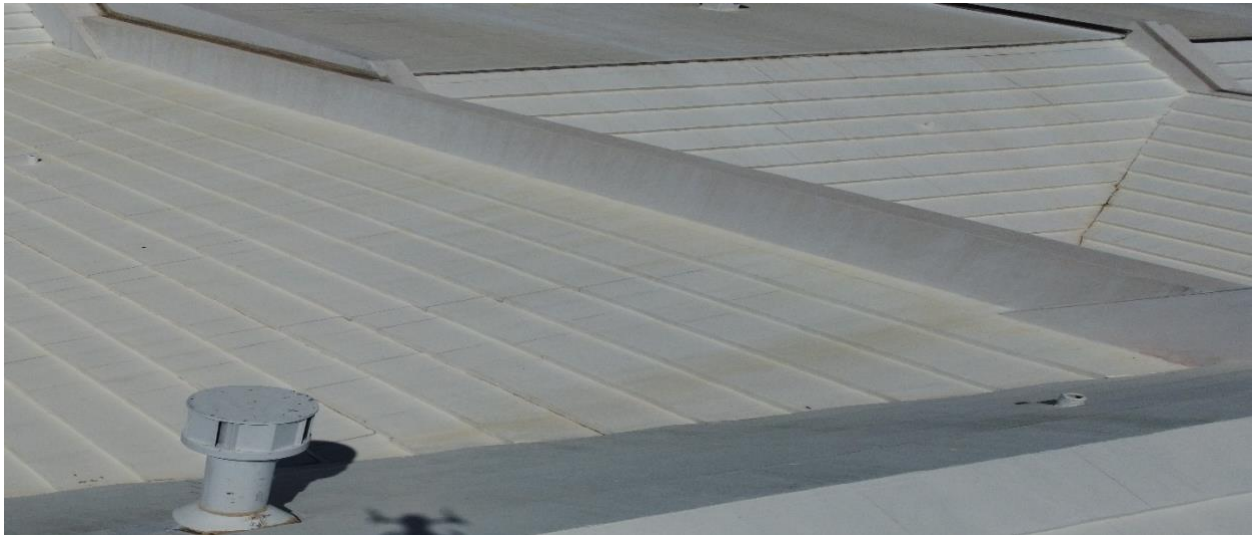
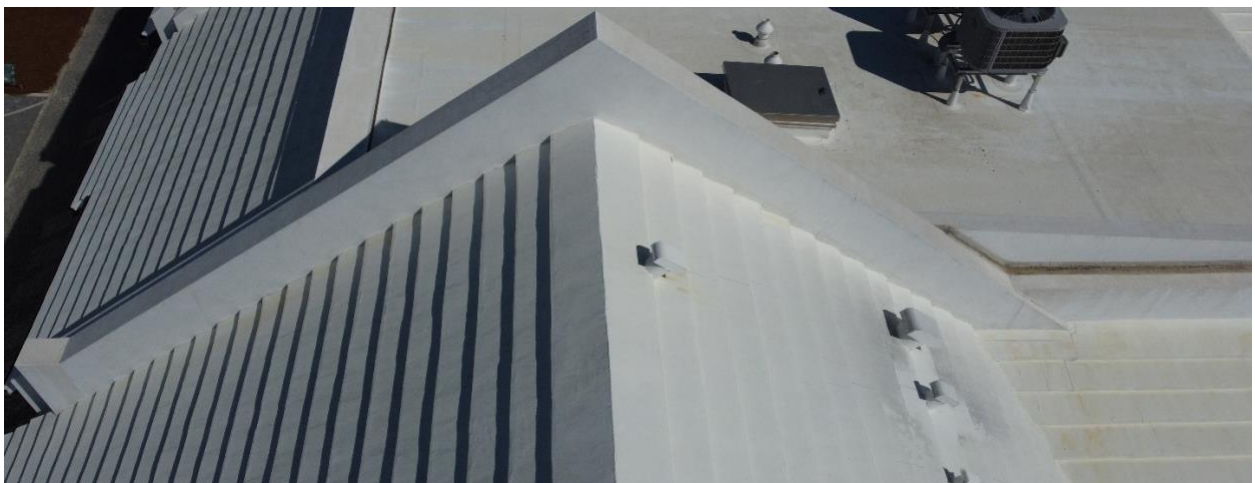
**Parapet Walls** - Visual elevations of parapet walls where roof ends identified to be in good overall condition needing no immediate attention.

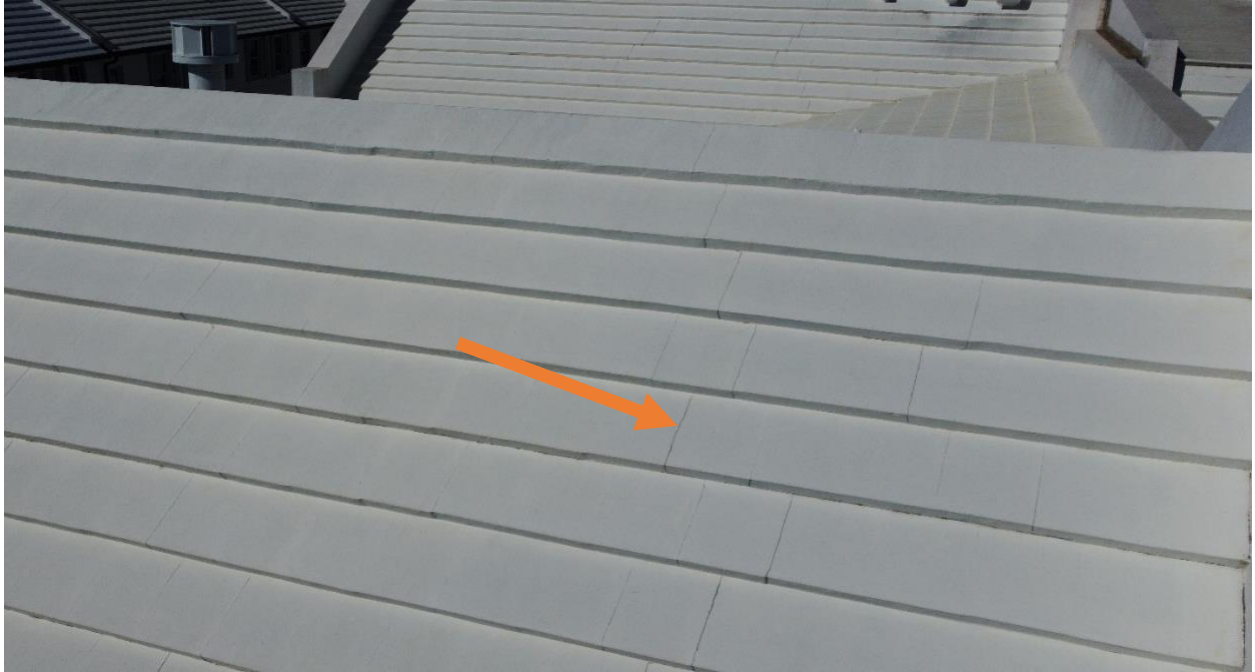
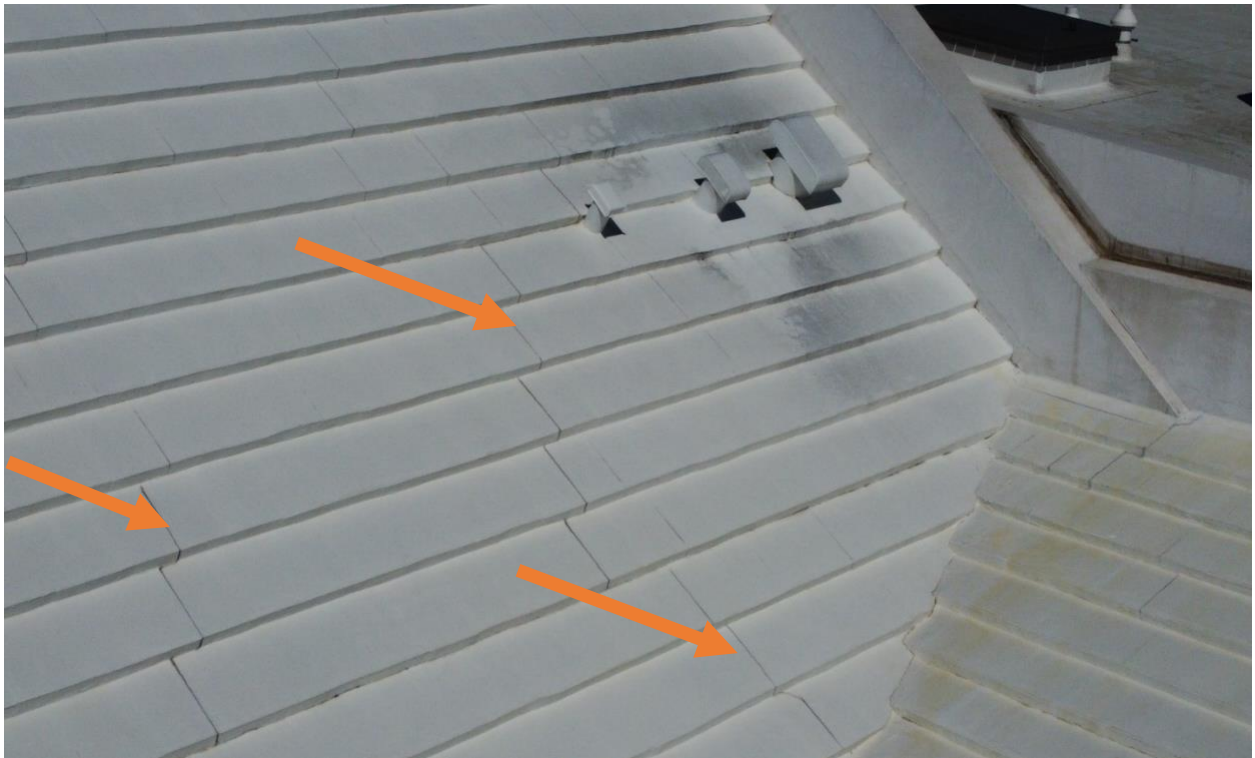
**Roof Surface Areas** - Visual elevations of surface areas identified to be in good overall condition with slight separation/cracking that should be monitored for any further separation. Concrete roof separation/cracking does not always mean a leak will occur, but a solid roof area should always be maintained.

**Closing** - Visual elevations given in report reflect exterior roof conditions and discoveries. As reported the various roof components overall are in good condition needing no immediate attention as of the date of this report. However, the concrete roof surface area should be monitored/repared to maintain a solid surface area. For any questions regarding construction or warranties in place, please contact your builder. Annual exterior visual observations are highly recommended as well as after any significant weather events.

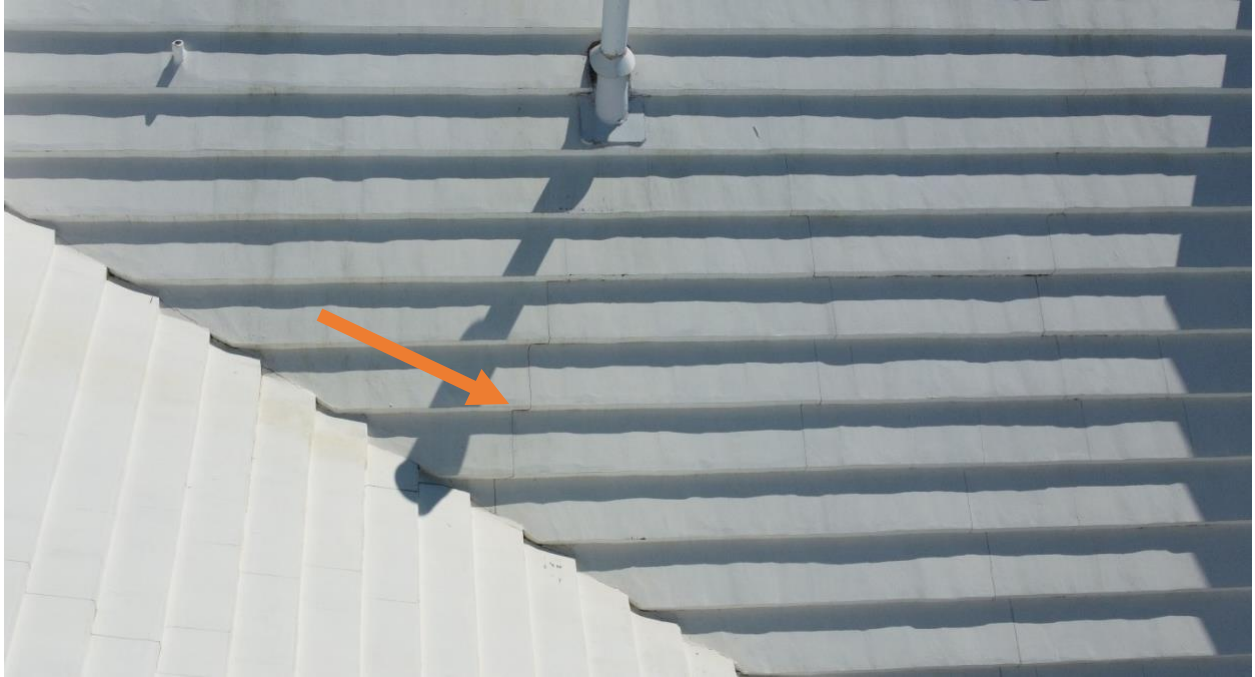
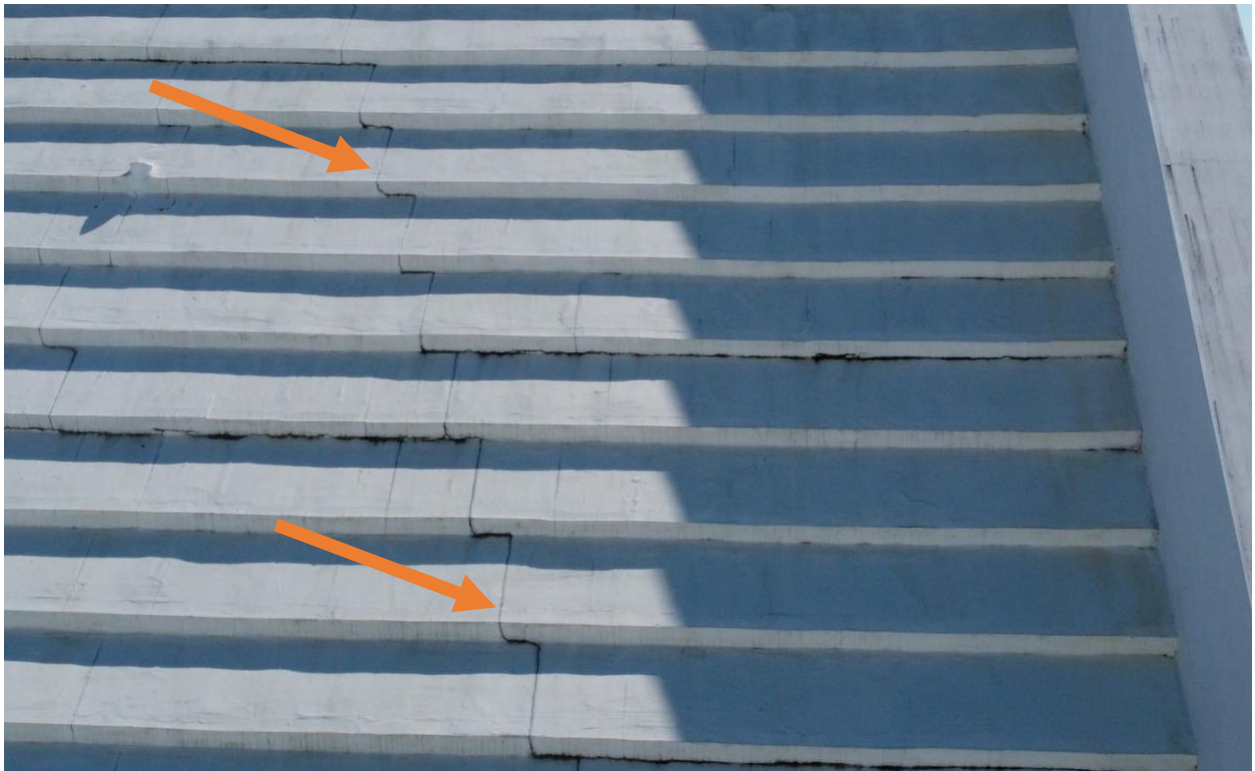
**Roof Surface Areas** - Visual elevations of surface areas identified to be in good overall condition with slight separation/cracking that should be monitored for any further separation. Concrete roof separation/cracking does not always mean a leak will occur, but a solid roof area should always be maintained.
